REPORT NO. 710/14

TEST OF COMPOSITE PLATES FOR
ARMOR PLATE

Report No. 710/14
Watertown Arsenal

Test of Composite Plates for Armor Plate

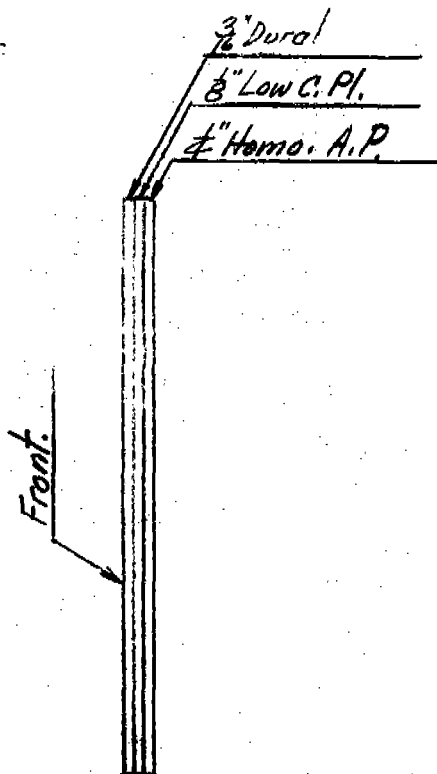
PLATE NO. Combination "A"

Combination "A" plate was put together as one plate without any spacing between the plate; this combination failed completely. The combination of plates was fired both at the front and back. The back of the plate when fired at, gave better results than the front; when fired at the front the cores made complete penetrations, but firing at the back, the cores stayed in the plate, the points just coming through the opposite side.

Rounds 1 to 4 inclusive were fired at front side of plate. Rounds A to C inclusive were fired at back side of plate.

ROUND NO.	STRIKING VELOCITY	REMARKS
1	2460	
2	"	Comp. penetratio
3	"	"
4	"	"
A	2460	"
B	"	Comp. penetratio
C	"	points of core just through and core stayed in plate.

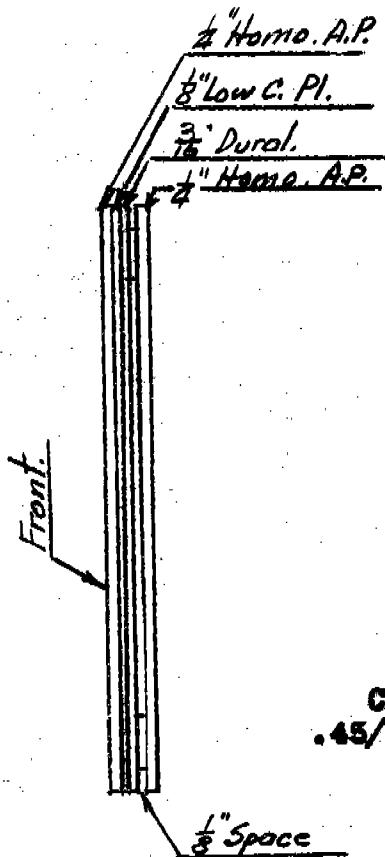
PLATE NO. Combination "B"

Combination "B" plate was made up as shown on sketch, with a space between the last and next to the last plate. Three rounds of service velocity (2460 f.s.) were fired at the plate here at Watertown Arsenal, and it was found that the cores stayed in the plate without damage to the back plate.

This plate was found very good using 2460 f.s. velocity ammunition and Springfield rifle, and plate was sent to Frankford Arsenal for further firing test, the results of which are included within the pages of this report.

S, S, & S.	2460	Bulged dural to face of back plate-no damage on back plate.
------------	------	---

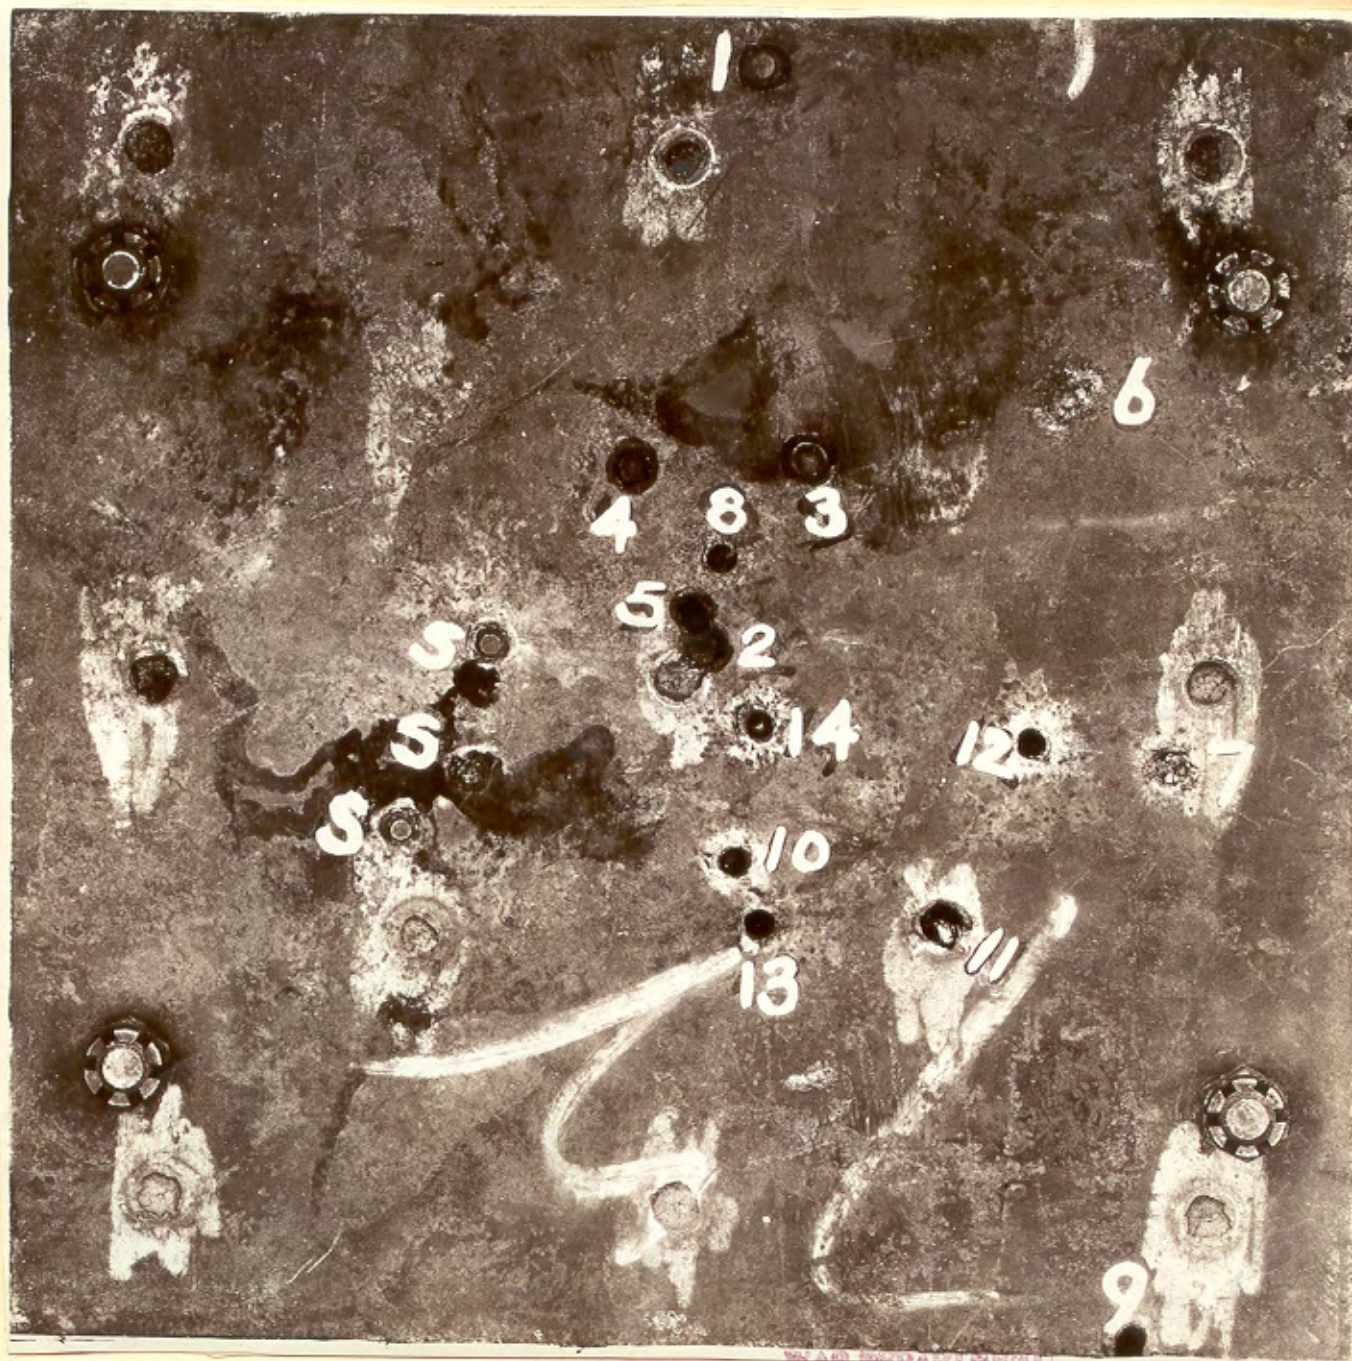
710-25

FRONT
OF
FRONT PLATE.

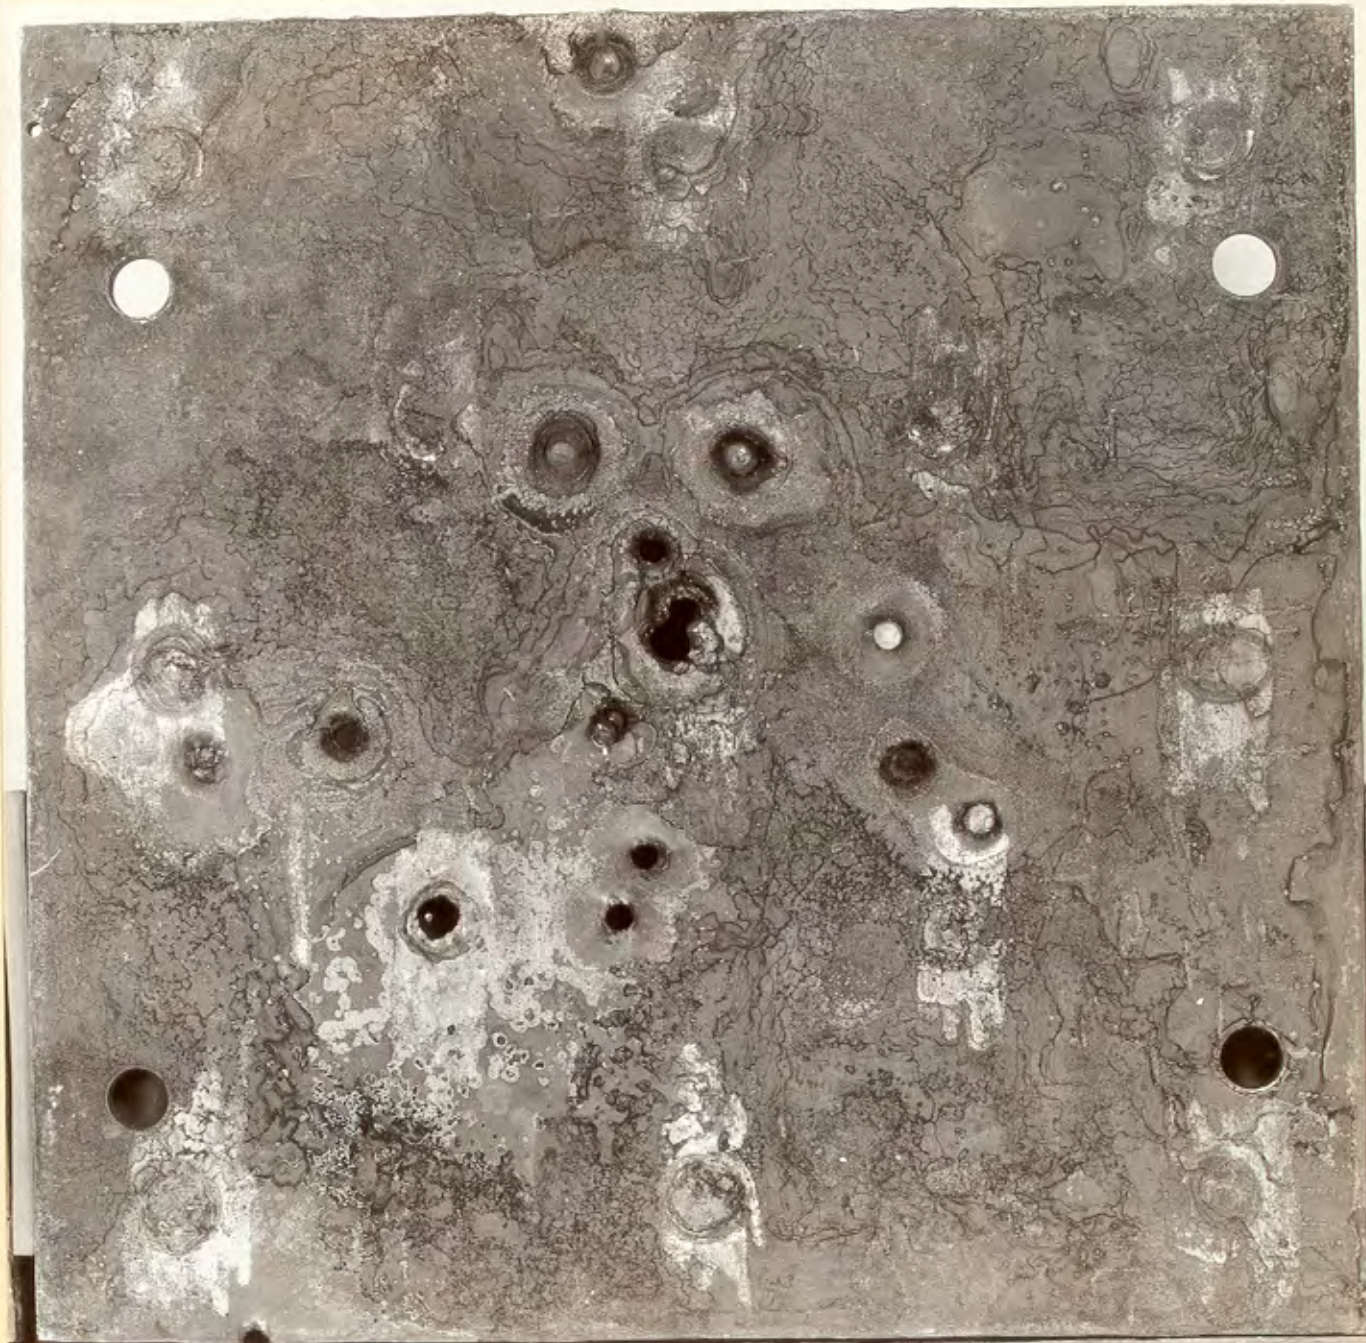
710-26

BACK
OF
FRONT PLATE.

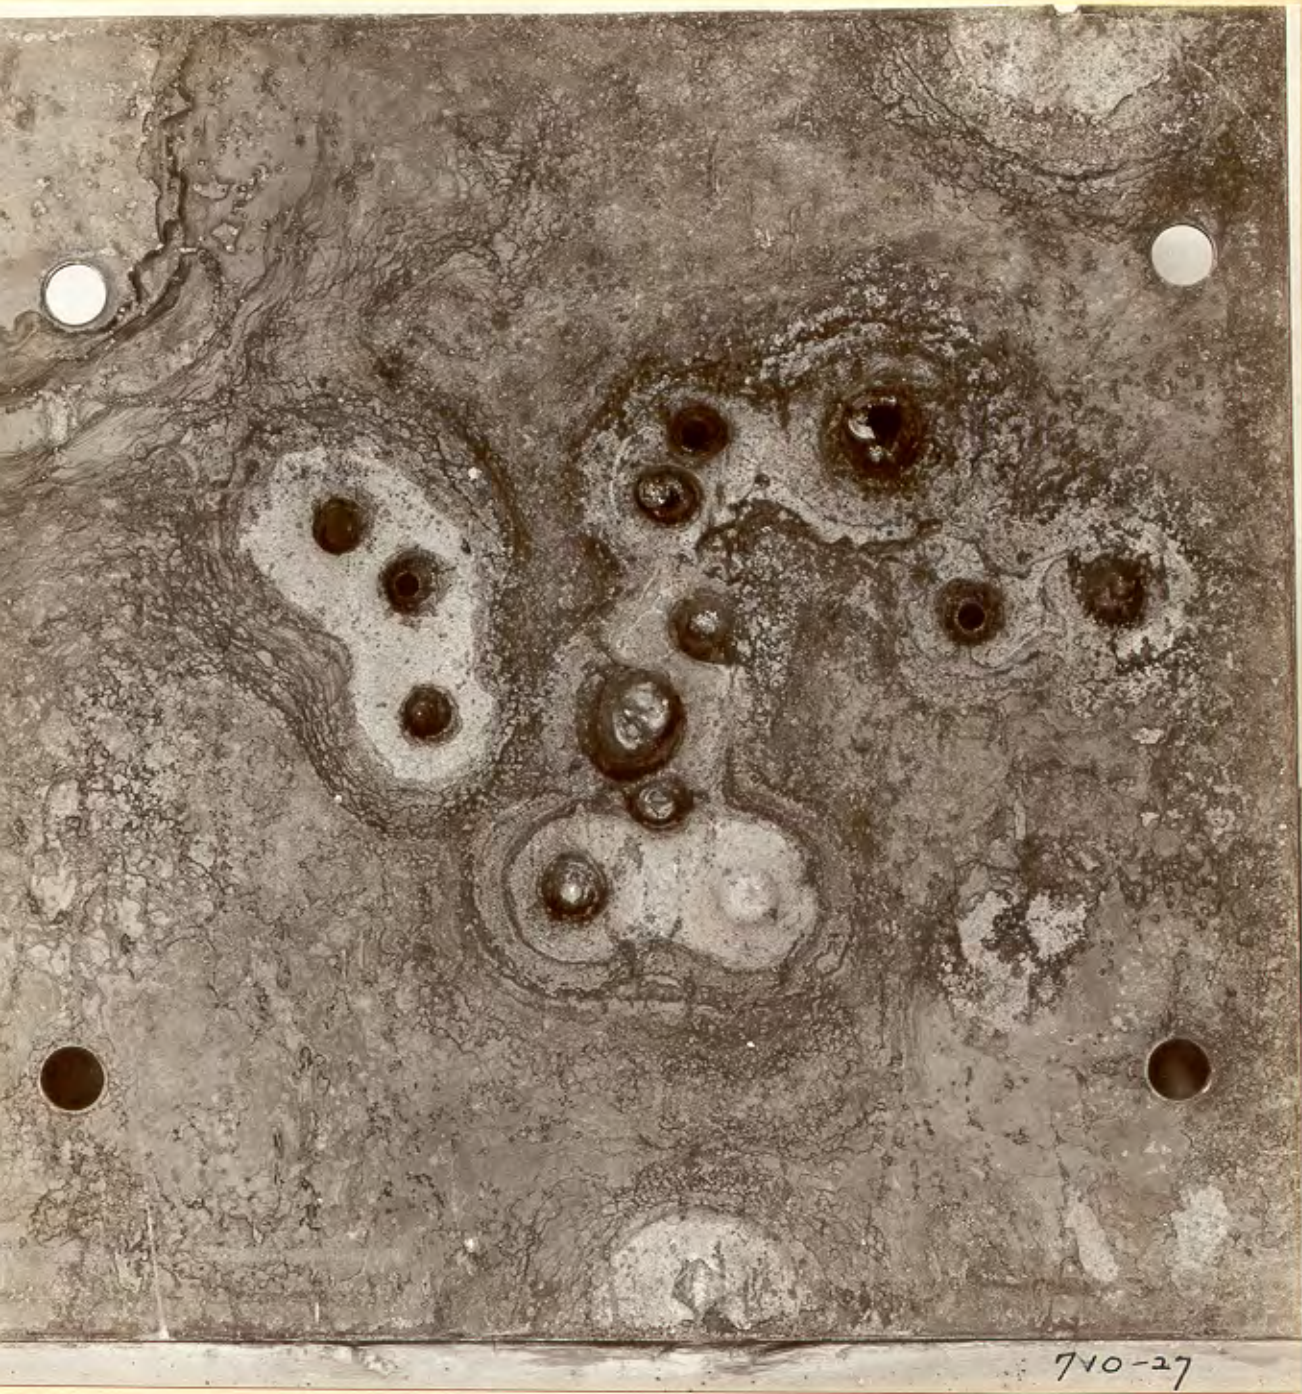
The photographs at the back of this report should be studied and special attention should be paid to the condition of the low carbon steel 1/8" plate and the dural sheet which gave with the core and flattered against the back plate.

FRONT
OF
LOW CARBON PLATE.

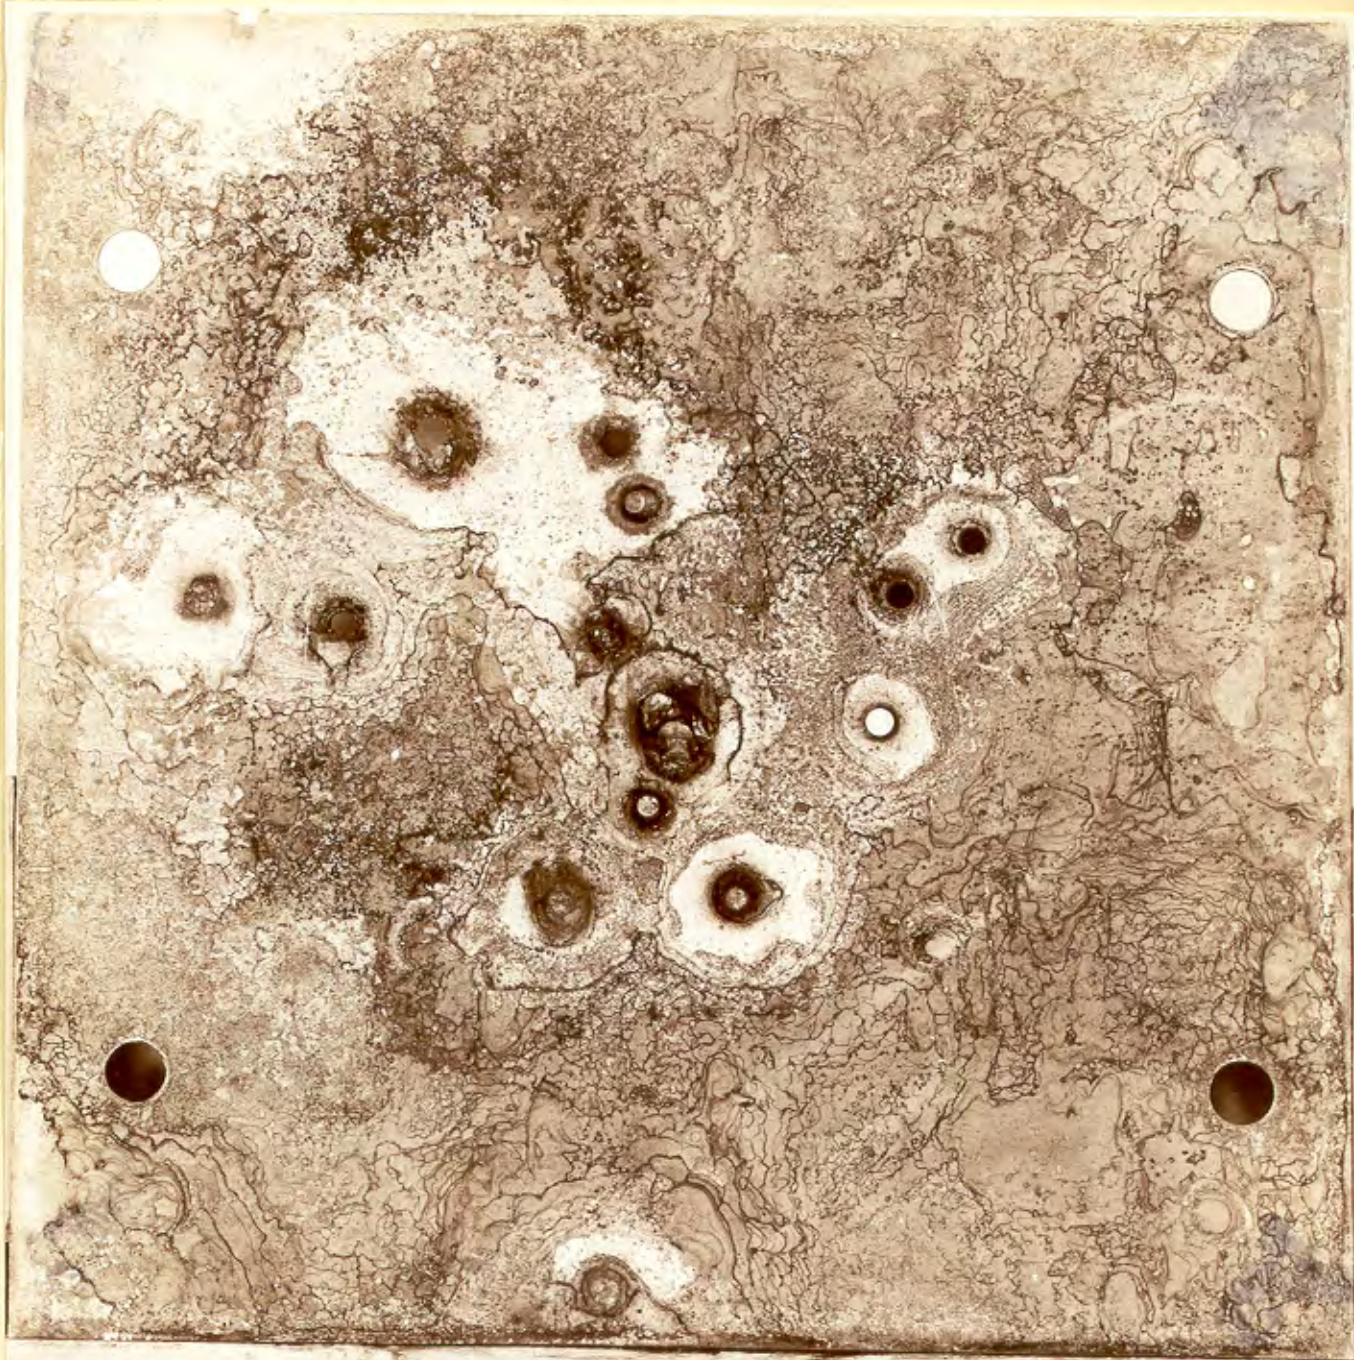
710-2B

BACK
OF
LOW CARBON PLATE.

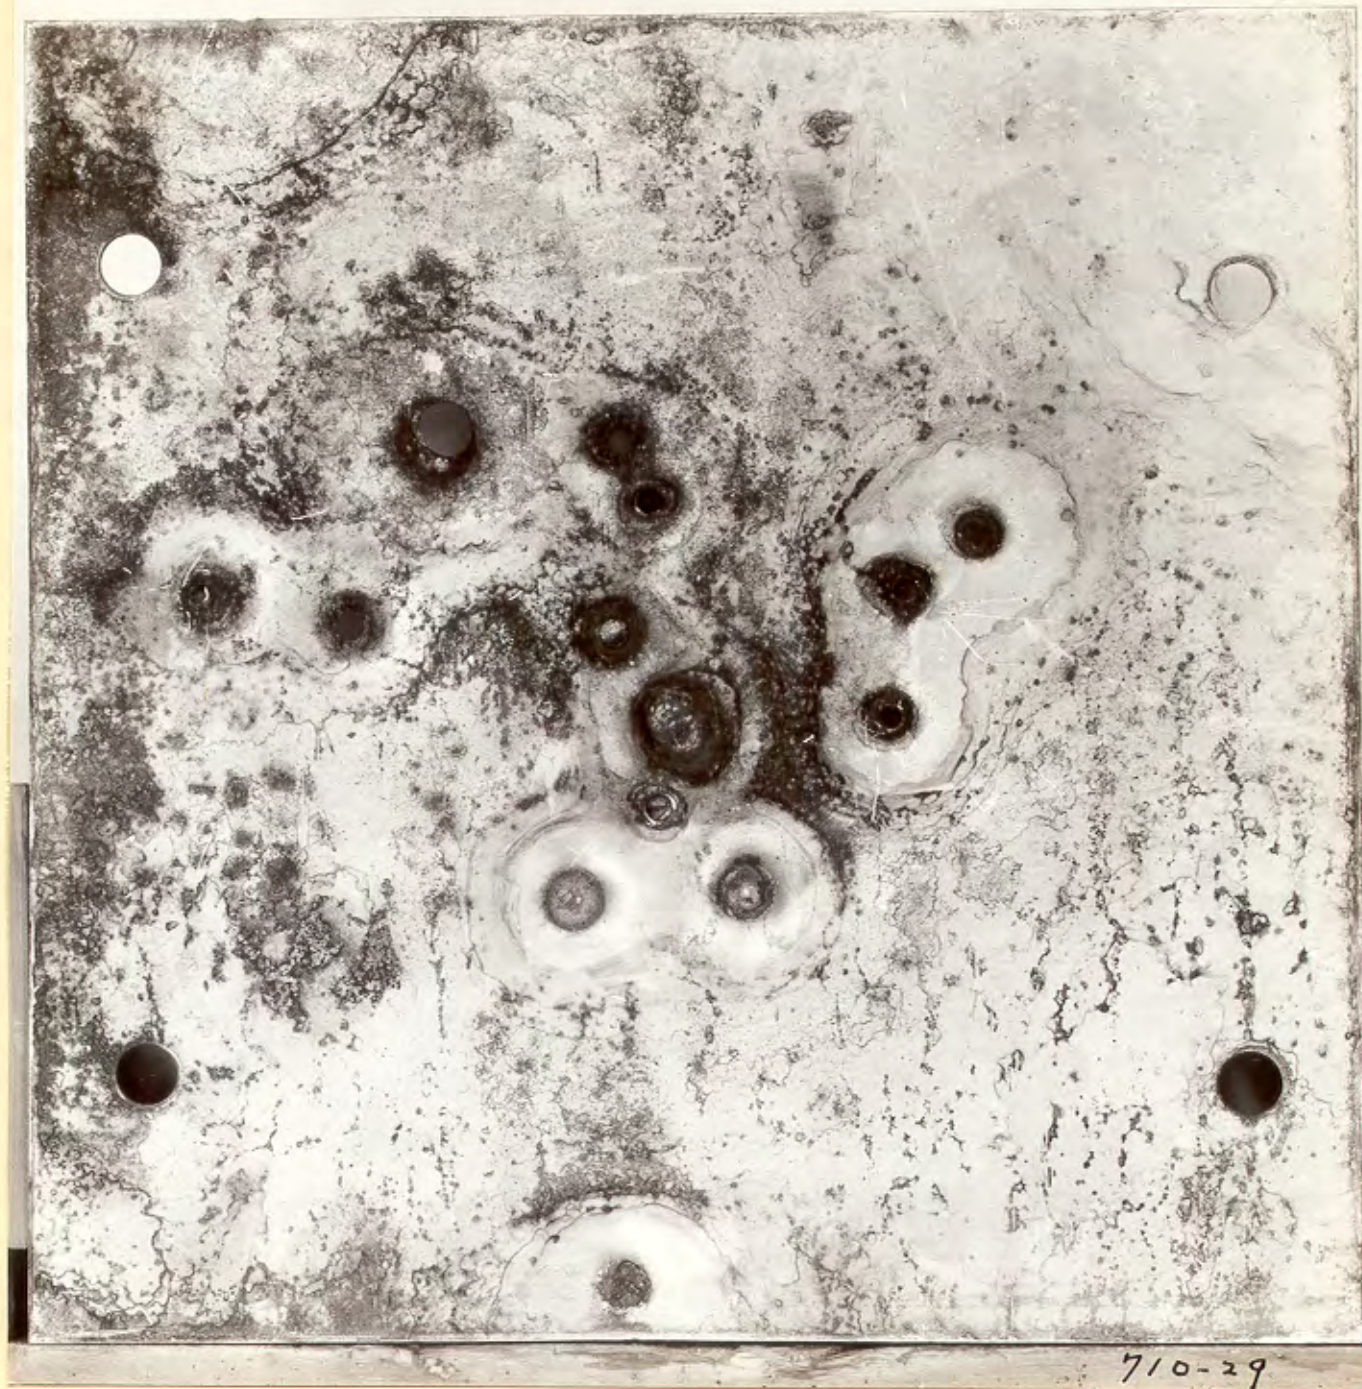
710-29

FRONT
OF
DURAL PLATE.

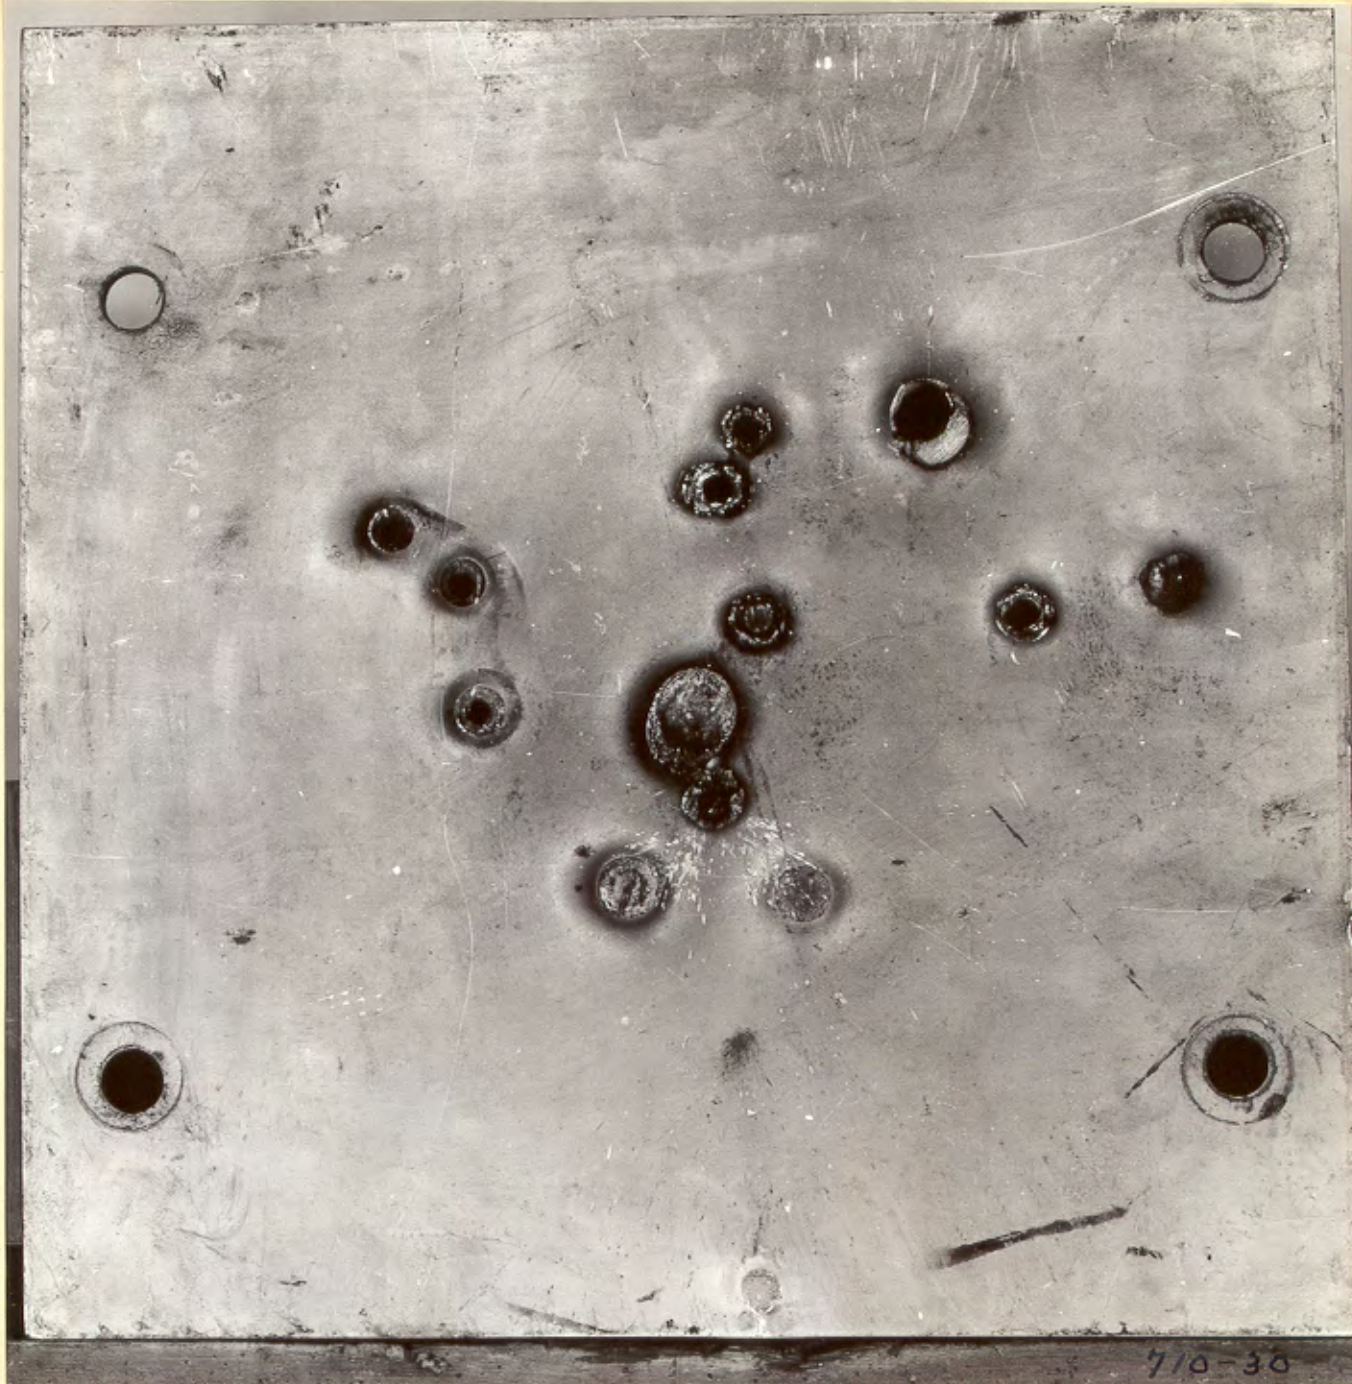
7/0-30

BACK
OF
DURAL PLATE

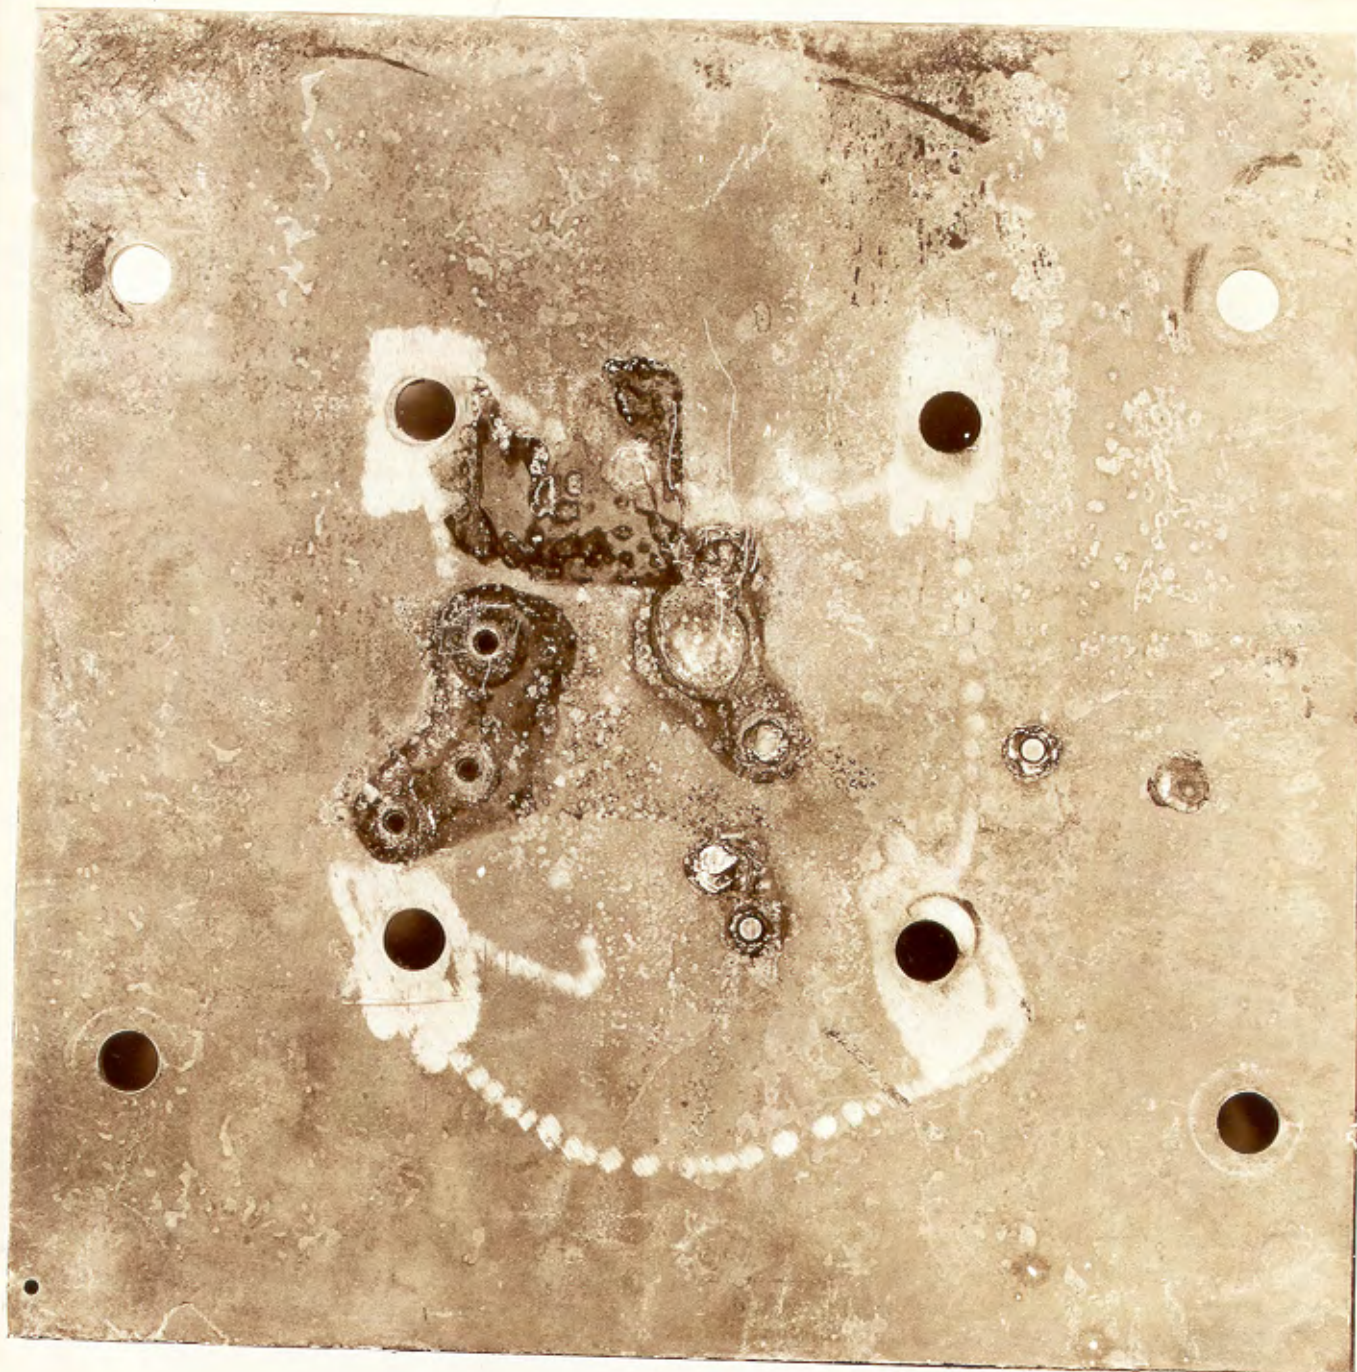
710-31

FRONT
OF
REAR PLATE

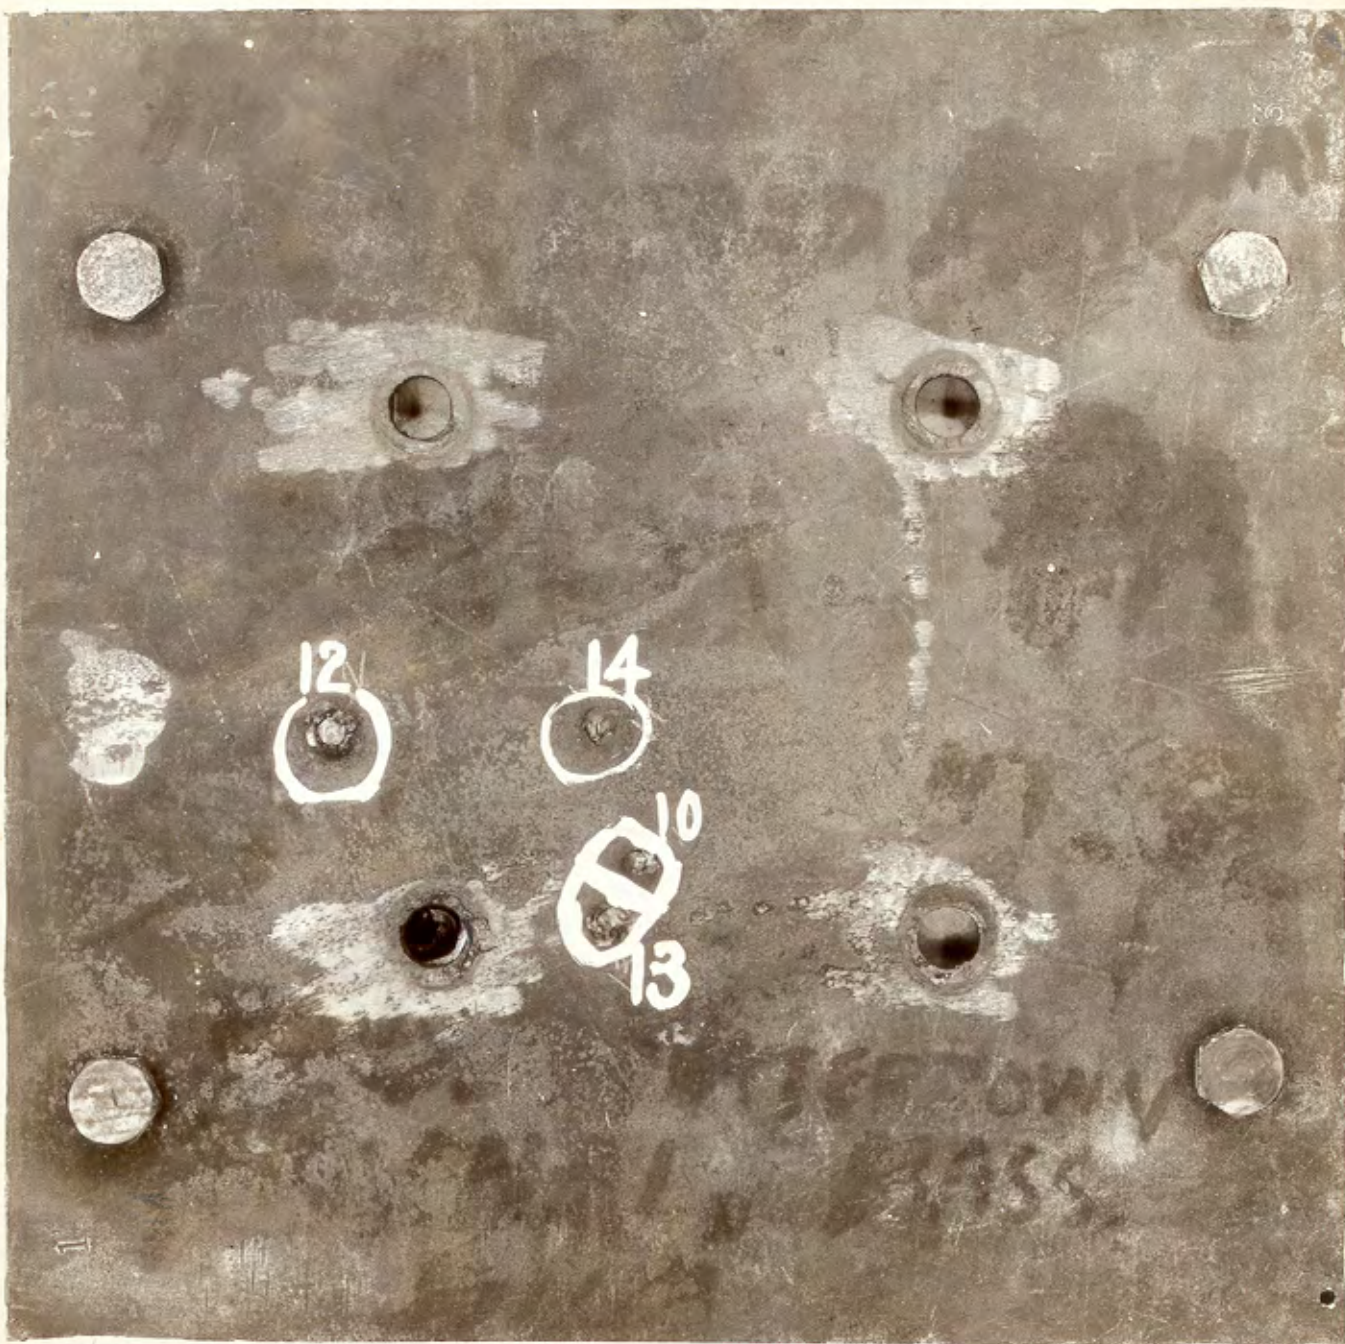
710-24

BACK OF REAR PLATE
REAR OF COMPOSITE PLATE
